# Wetlands and Reefs: Two Key Habitats

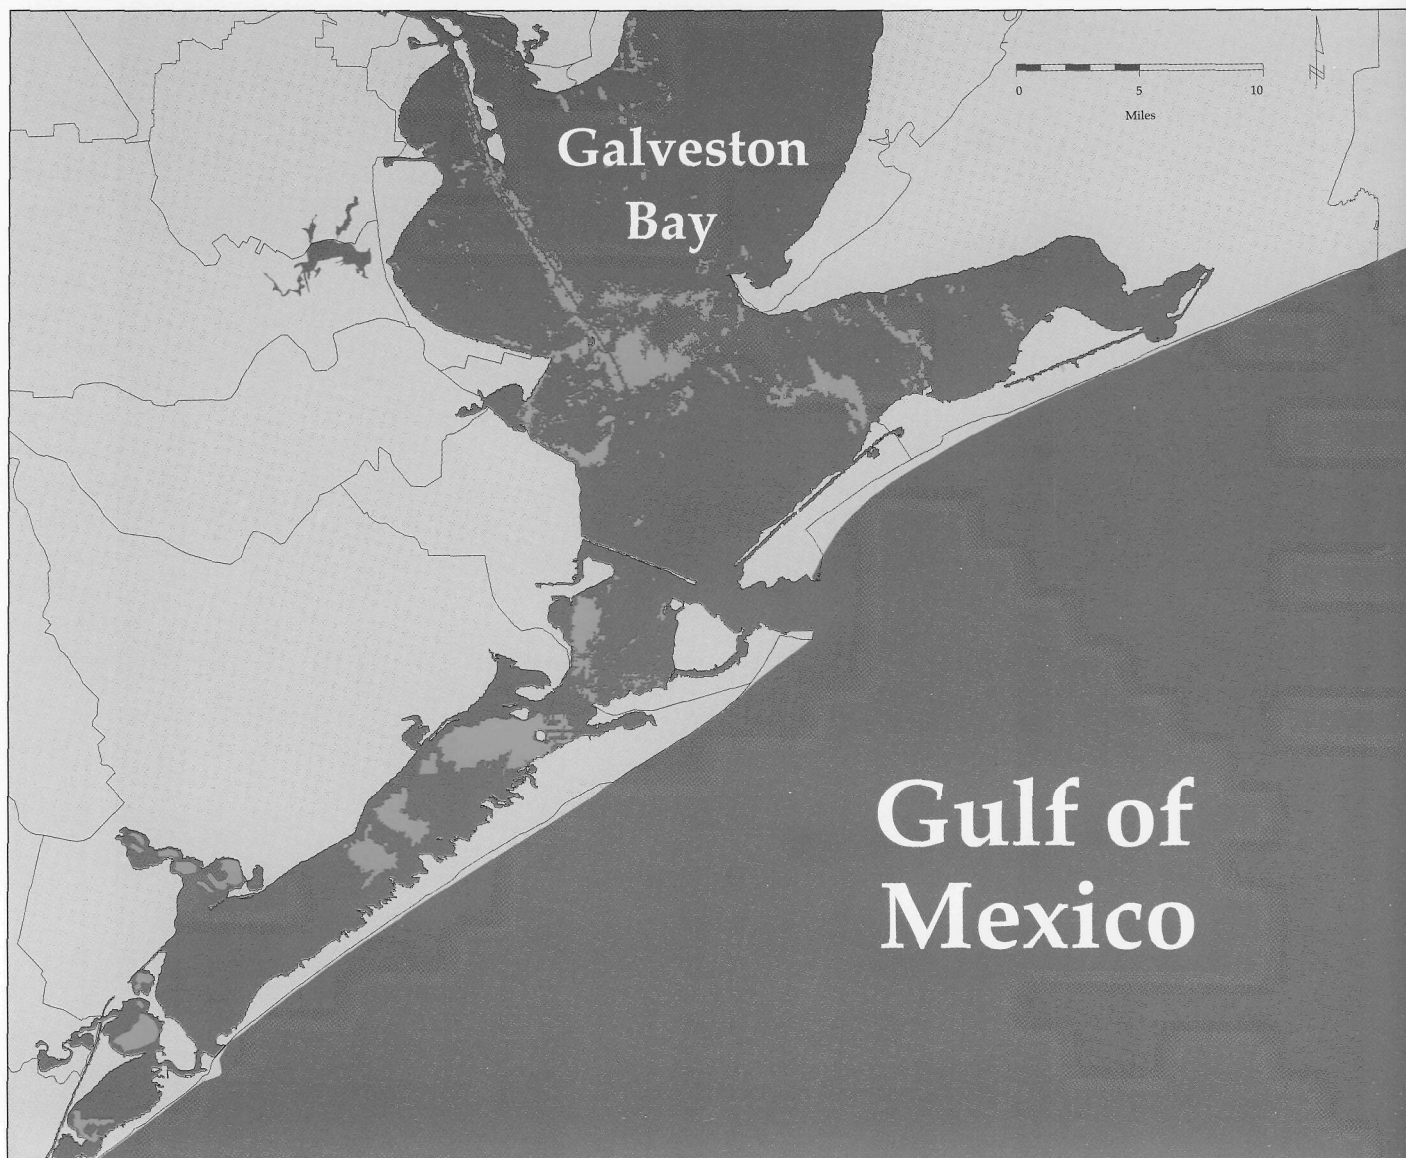
**FIGURE 7.8.** Oyster reefs and shell-dominated bottom in Galveston Bay, shown in red. This map is based on a survey which used state-of-the-art sonar, global positioning, and geographic information system technologies.
